Shawford Parish Hall

An assessment of sinking fund requirements

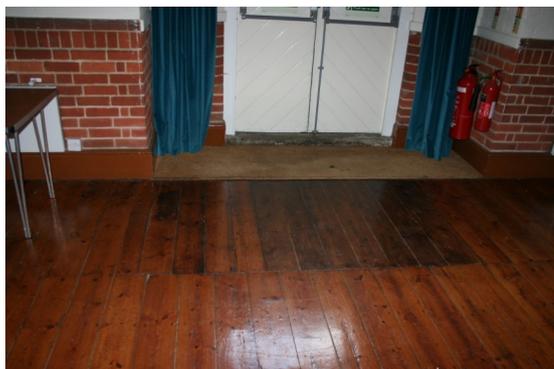
factors that will influence its longevity. The external ground level aligns with the floor and whilst this is useful for escape door purposes it has resulted in damp penetration as evidenced by the replacement of boards close to the rear escape doors. Ways should be sought to lower the ground level and incorporate ramps to the doorways.

Another related factor is the apparent lack of ventilation to the sub-floor. It was reported to me that when boards were renewed some joist ends were found to be rotten and needed replacement. It is important for the longevity of the floor that a proper investigation is done to ascertain the extent of any rot problems and that the ventilation of the sub-floor is improved as a matter of urgency.

I think that a sum of £500 should be assigned to an investigation involving the removal of perimeter floor boards to view the state of the joists and a further £1500 to excavate & install vent ducts from the sub-floor to above ground level. This expenditure could save more serious problems in the future. For the purposes of this exercise I am assuming that some problems will be found with the joists and have allocated £2000 in the second year for remedial works. If total renewal of the joists becomes required, involving lifting the boards and also inserting insulation then a sum of £8500 should be allocated.

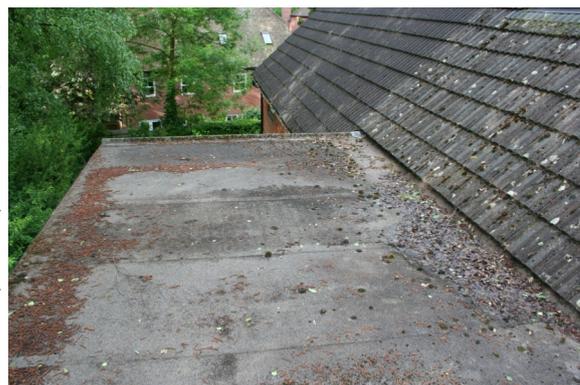
The flat roof to the store has inadequate falls and suffers from ponding. The life of the felt will be greatly reduced by this and the covering should be replaced within the next 5 years with a modern single ply covering, on the deck modified to give greater falls. The deck seems sound but will suffer if the covering fails. I suggest an allocation of £5000 in year 5.

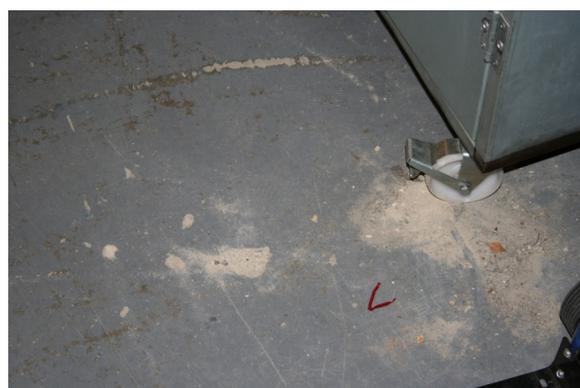
The store floor is suffering damage from sharp objects being dragged over it. Consideration should be given to repairing it and coating it with an epoxy finish. £2000 is allocated as an extra.

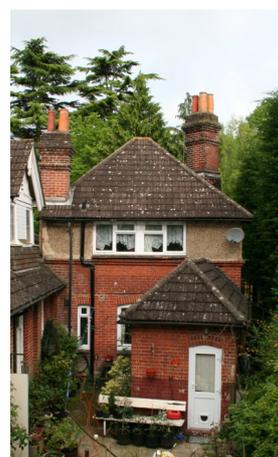
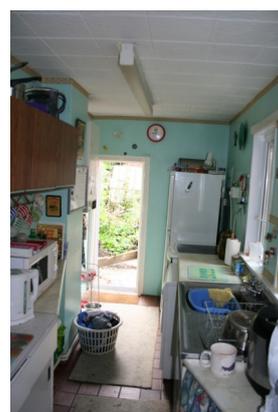
The cottage is in need of major refurbishment. It suffers from damp and some timber infestation and needs the modernisation of fixtures and fittings.

Items needing attention include: installation of injected dpc, renewal of floors, replastering after dpc installation, rewiring, replumbing, roof insulation, timber treatment, works to the roof and chimneys, new kitchen units and new sanitaryware and redecoration throughout.

Ideally a total refurbishment costing some £40,000 is necessary but it may be possible to limit this to the bare necessities of making the fabric sound for around £20,000.
